**Region 9 Enforcement Division
75 Hawthorne Street
San Francisco, CA 94105**

SECTION I – INTRODUCTION

I.1 Purpose of the Virtual Inspection

The purpose of the virtual inspection was to evaluate the operation of Hilmar Cheese Company's (Hilmar, Facility) Class I injection wells for compliance with the U.S. Environmental Protection Agency's (EPA) Safe Drinking Water Act (SDWA) and the Facility's Underground Injection Control (UIC) permit No. CA10500001 (Permit). This virtual inspection was conducted via a Microsoft Teams video conference call.

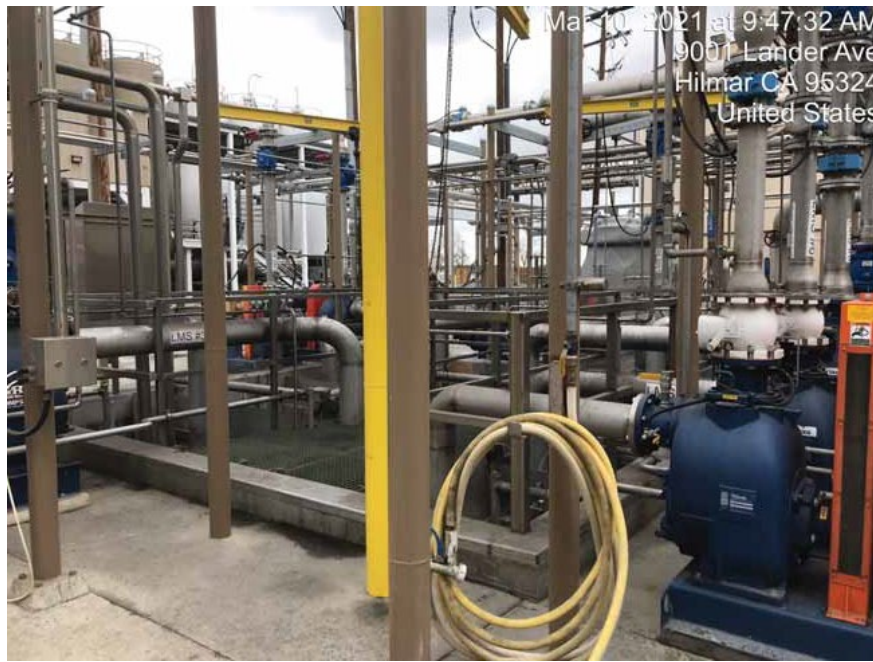
PHOTO 1 – Cheese pit collection sump

Two main pits collect process water (PHOTO 1) that is then pumped to equalization tanks. Equalization tanks transfer the water to Dissolved Air Flotation (DAF) units #4, 5, and 6, which pull solids and fats from the process water. From the DAFs, the water runs through an anaerobic and aerobic digestion process. From the digestion process, the water passes through

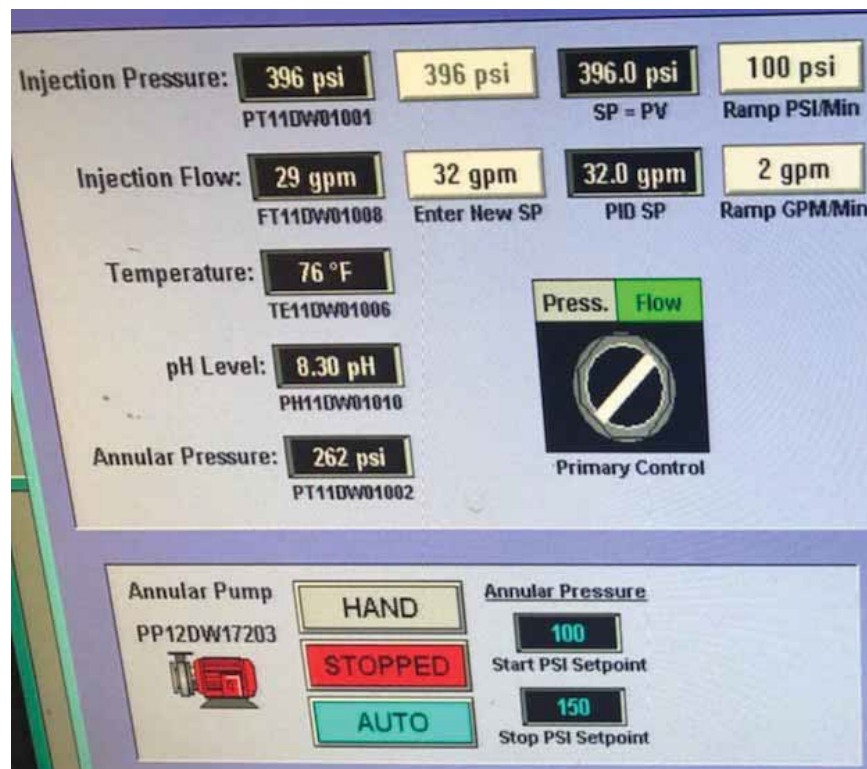
PHOTO 2 – WD-3 Control Screen

- Ms. Connel stated that well WD-3 has a booster pump attached which kicks on if the well experiences a drop in pressure, and that she was uncertain of what the setting is that triggers the pump. She also stated that there is no alarm system on the well to alert operators of an uncharacteristic drop in pressure.

- PHOTO 2, taken by Ms. Connel after the virtual inspection, shows an annular range pump setting for well WD-3 starting at 100PSI and stopping at 150PSI.

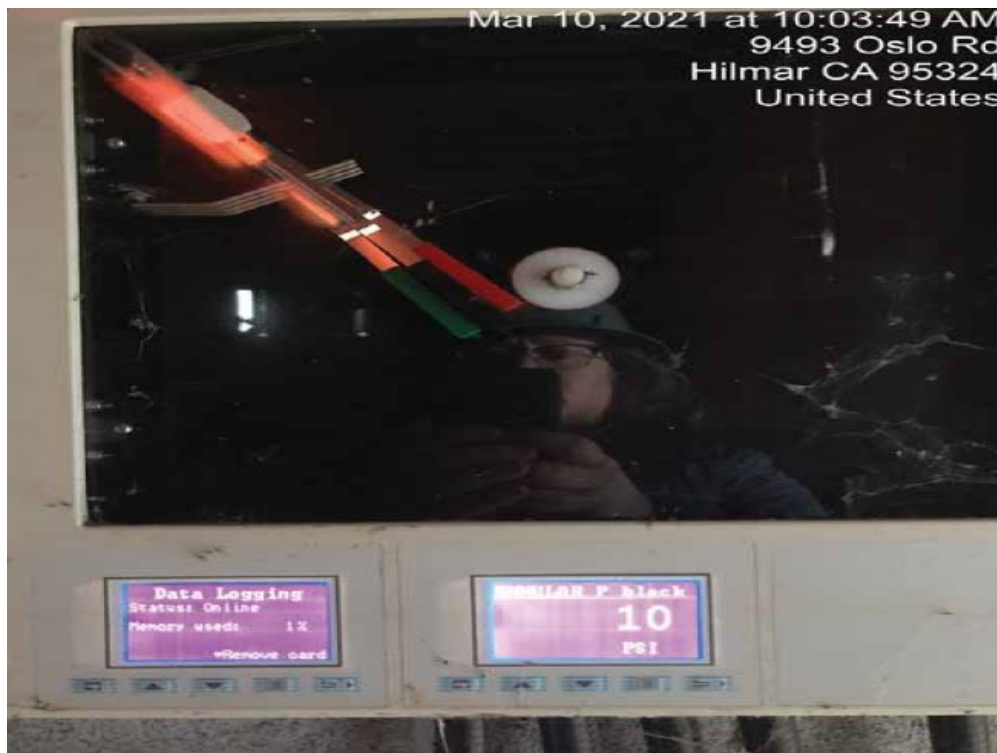
PHOTO 3 – WD-2 Data System Readout

- PHOTO 3 shows an annular pressure data system readout of 10PSI at well WD-2 on March 10, 2021 at 10:03AM.
- PHOTO 4 shows an annular pressure gauge reading of 10.0PSI at well WD-2 on March 10, 2021 at 10:07AM.

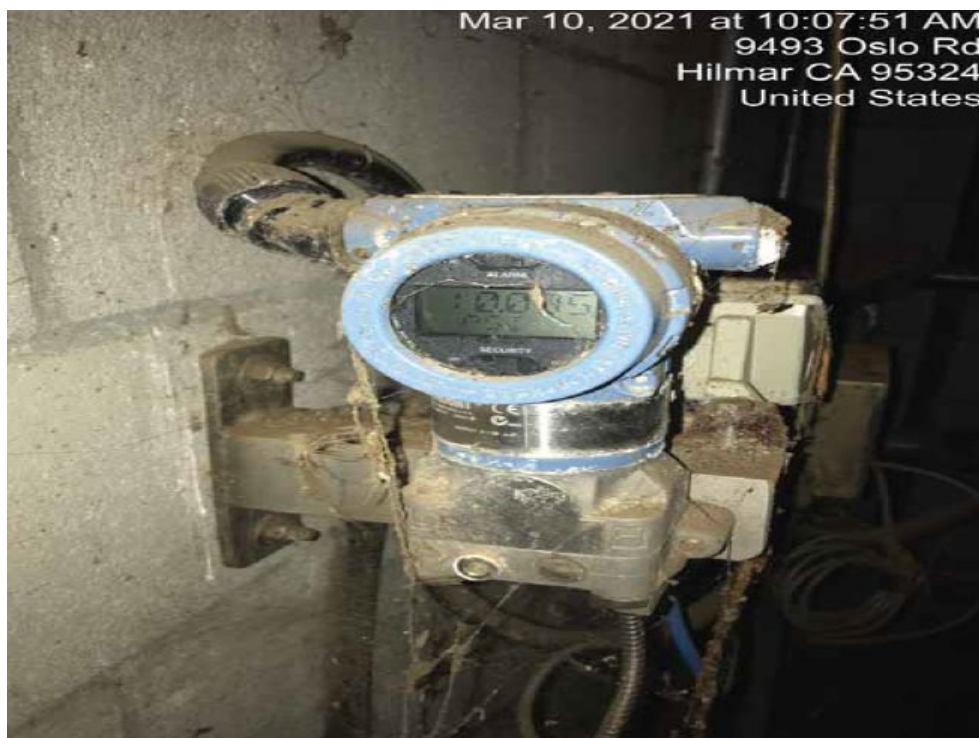
PHOTO 4 – WD-2 Annular Pressure Gauge

a) Item C.8.b of the Permit requires that 100PSI be maintained on the tubing and annulus during shut in conditions. Well WD-2 has been shut in since March 2012. The injection pressure reading observed during the virtual inspection was 0PSI and the annular pressure was 12PSI. PHOTO 4 shows an annular pressure reading of 10.0PSI. Failure to maintain 100PSI on the tubing and annulus during shut in conditions constitutes a potential violation of the Permit.

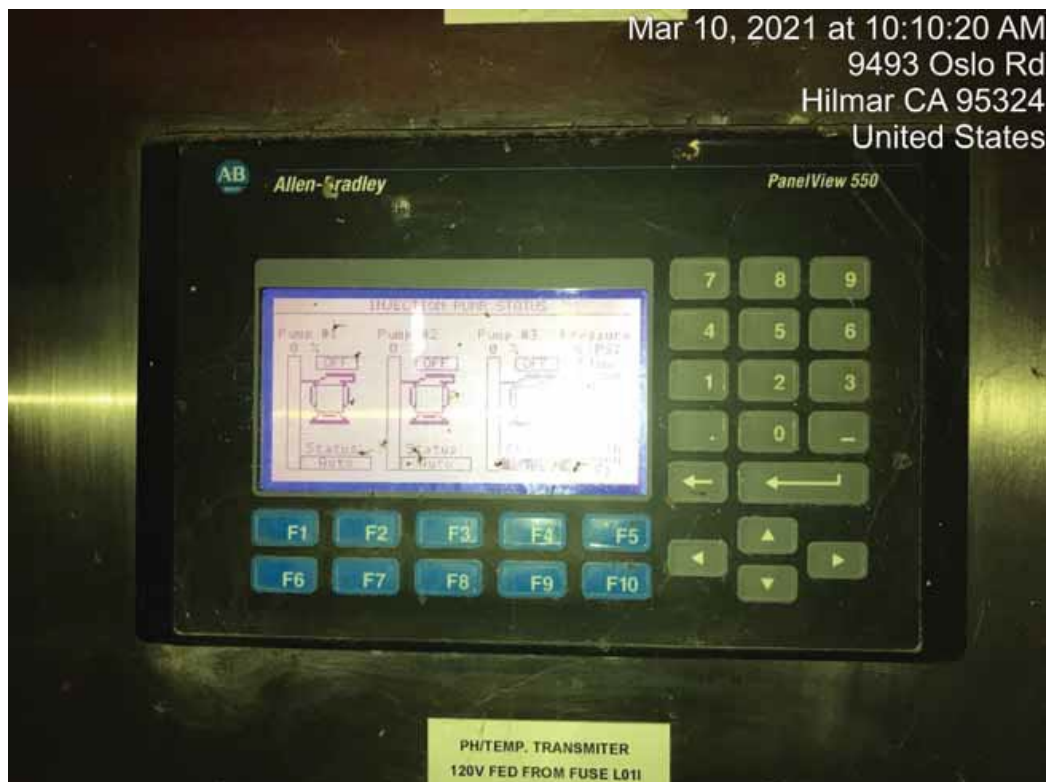
PHOTO 16 – WD-2 Data System Readout with injection pumps showing “off”

- Ms. Connel stated that well WD-2 has been shut-in since March 2012, when Hilmar lost injectivity on the well. She stated that Hilmar is working to bring back the capability to inject into well WD-2, but it may not happen.
